NASA TM X-1794

**EXPERIENCES WITH BERYLLIUM
SWELLING AND REPLACEMENT
IN THE PLUM BROOK REACTOR**

by William Fecych

*Lewis Research Center
Cleveland, Ohio*

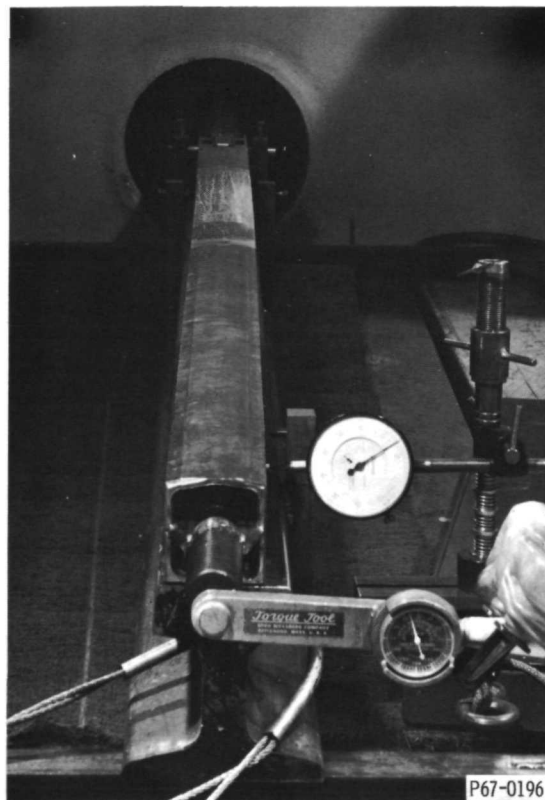
During control rod drop tests in February 1967, the control rod, located in core position LA-8, would stop under no-flow conditions about 1 foot from its seated dashpot position. The rod would fall properly when the locking bolt located on the top of the poison section was loosened. This allowed the control rod sections to hinge.

A special alinement jig was made to measure the assembled control rods (fig. 3). Figure 4 shows the alinement jig in the Hot Laboratory with a bowed beryllium section installed. The bowed assembled rod is shown to be $3/8$ inch away from the zero reference screw. Each beryllium reflector control rod section has an aluminum box at each end

Figure 4. - Control rod in alinement jig with bowed beryllium section.

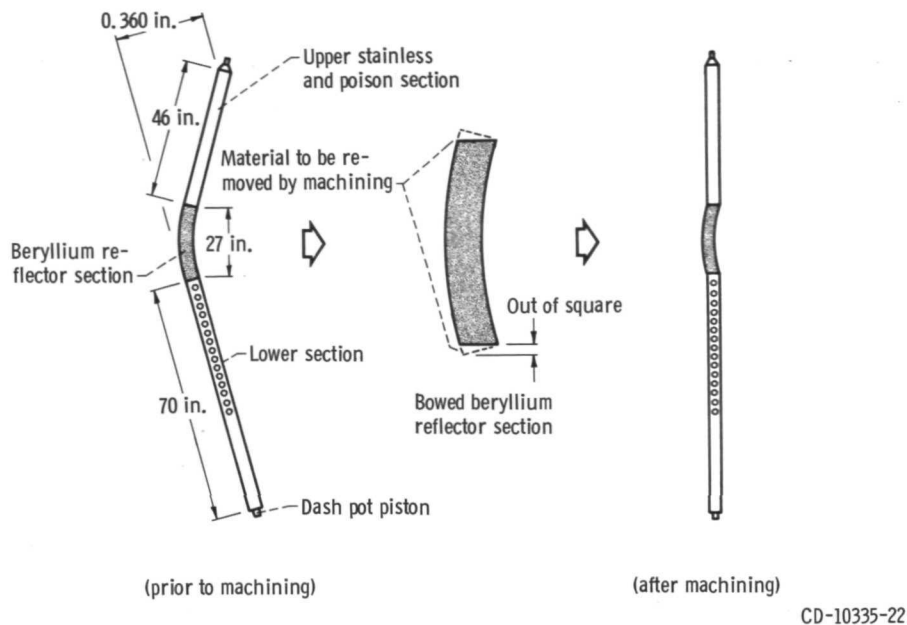
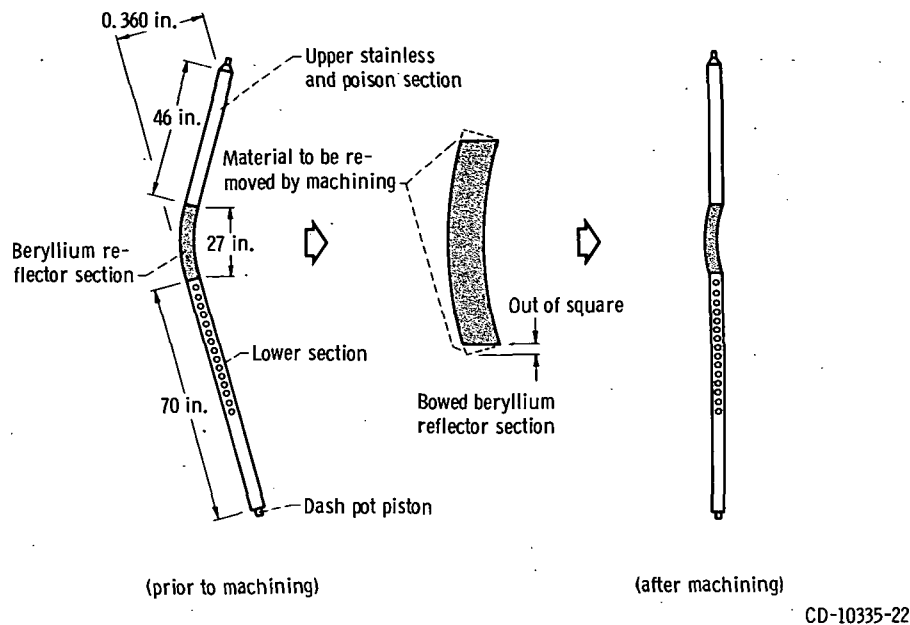
Figure 5. - Control rod (LA-8) with a bowed section installed and results with corrective machining.

which has the necessary mechanical devices for attachment. The beryllium section aluminum end boxes were mechanically machined parallel to provide proper alignment of the assembled control rods. Figure 5 graphically shows the results of this corrective machining.

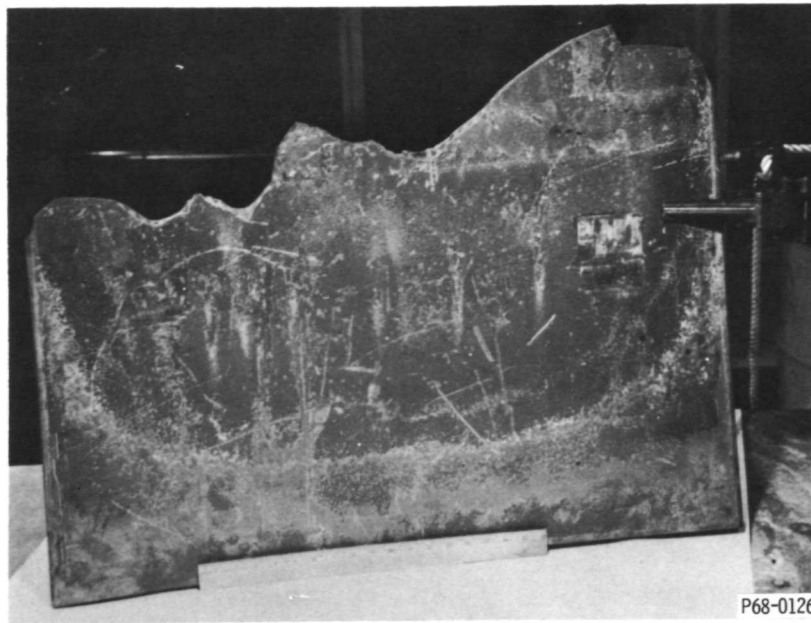
From the surveillance measurements on the south beryllium plate it was determined that the bowing rate towards the fuel elements was three times greater than expected. The plate, as it continued to bow, came into contact with the aluminum side plate of the fuel elements. Analysis and measurements indicated that the fuel elements could support the load. A visual inspection in February 1968 (37 256 MWD) indicated that the south beryllium plate had cracked during the cycle (fig. 6). A safety analysis had previously shown that reactor operations with a cracked plate would be safe and acceptable, and no abnormalities were observed during the cycle.

Figure 6. - Top half of broken beryllium south plate.

Beryllium has the desirable nuclear properties for use in a reactor, but lacks ductility, which limits its use in structures. The beryllium test specimens surveillance indicated a loss in the ductility with increasing neutron fluence. The failure of the south beryllium plate is typical of a brittle fracture. The maximum neutron fluence ($E > 0.1$ MeV) on the plate is 3×10^{22} neutrons per square centimeter, and the fluence at the side edges is 2.2×10^{21} neutrons per square centimeter. The fluences on the north plate are a factor of four lower.

To mechanically remove the inaccessible bolts which anchor the side plates to the lower grid, the entire core box would have to be removed from the supporting structure. This also would require the removal of all the precisely aligned beam tubes and through tubes. To avoid this major disassembly, the feasibility of using EDM was investigated. It had the following advantages:

After the lower bolts were severed using EDM with nickel electrodes, the north plate and the top half of the broken south plate were lifted out. The lower half of the south plate could not be removed mechanically because it had swelled and was wedged into its retaining slots in the aluminum side plates and the lower grid. Various mechanical pulling devices were tried. Attempts to drill holes in the plate for attachment of pulling devices were unsuccessful. The mechanical properties of the plate varied. It crumbled in the

high fluence areas and was extremely hard at the sides and bottom so that elaborate drilling fixtures would have to be made to perform this remote underwater operation. Consequently the EDM was used to remove the plate.

The design of the north and south plate was changed to

- (1) Make the plates interchangeable
- (2) Make each plate so it could be rotated to bow in the opposite direction
- (3) Reduce the thickness by 0.005 inch where the plate is held in the lower grid and end plate slots
- (4) Cut back the sides and the bottom of the plate 0.025 inch to allow for length and width growth
